**FINAL**  
**Coal Ash Impoundment –**  
**Specific Site Assessment Report**  
**Westar Energy**  
Jeffrey Energy Center

Submitted to:  
**Lockheed-Martin Corporation**  
2890 Wood Bridge Avenue  
Building 209 BAYF  
Edison, NJ 08837

Submitted by:  
**GEI Consultants, Inc.**  
6950 South Potomac Street, Suite 300  
Centennial, CO 80112

September 2009  
Project 091330

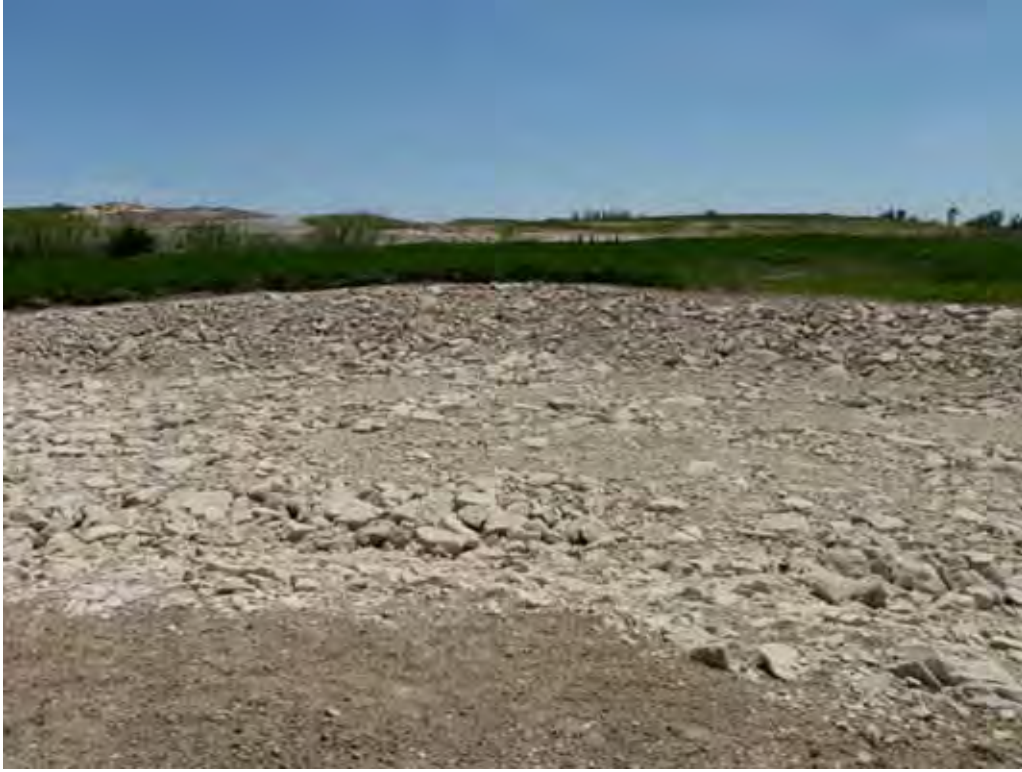
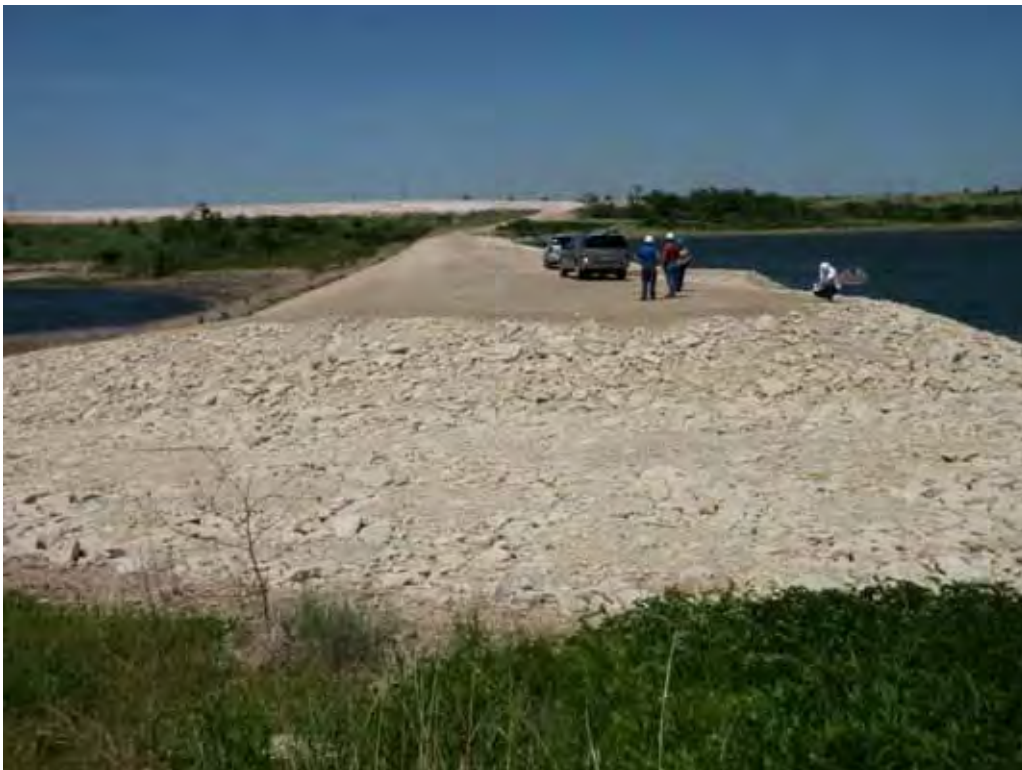
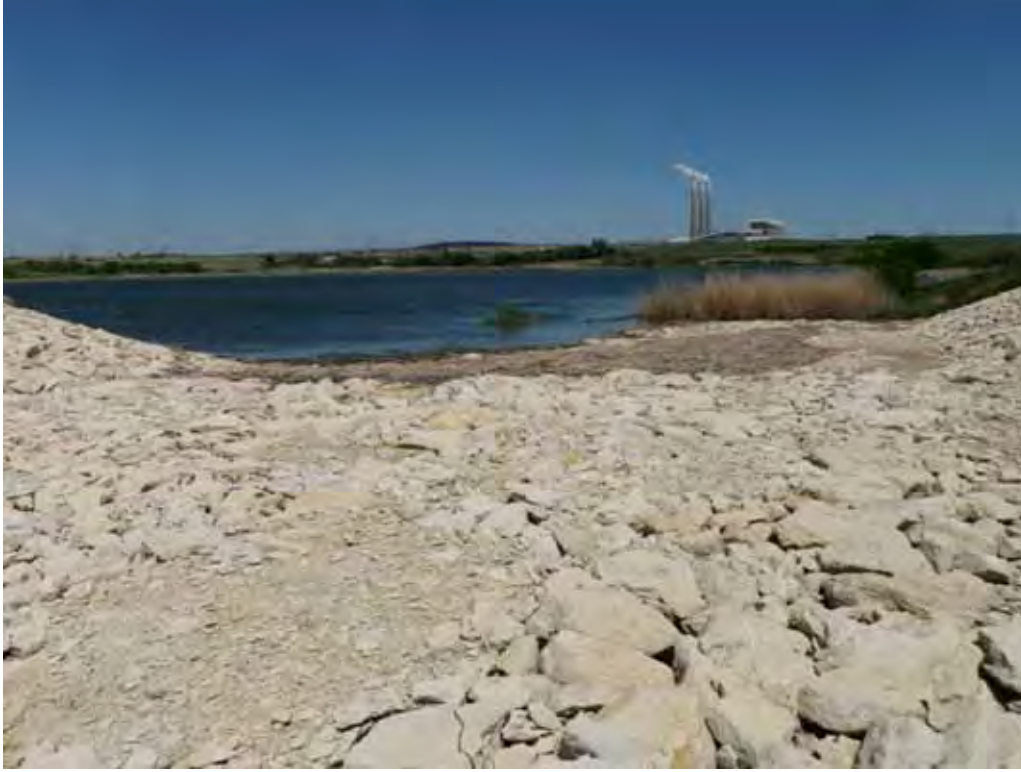
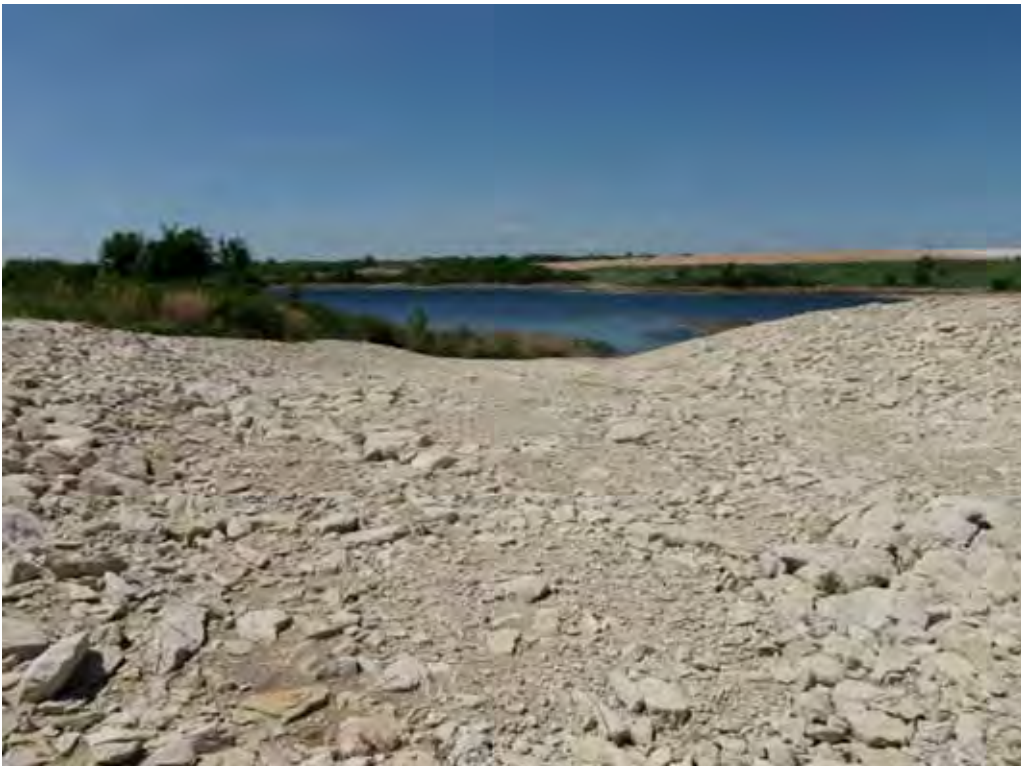
The emergency spillway appeared to be in good condition (Photos BAP 1 – 4). The riprap protection was fairly consistent for the entire length of the spillway and only showed minor signs of deterioration (Photo BAP 9).

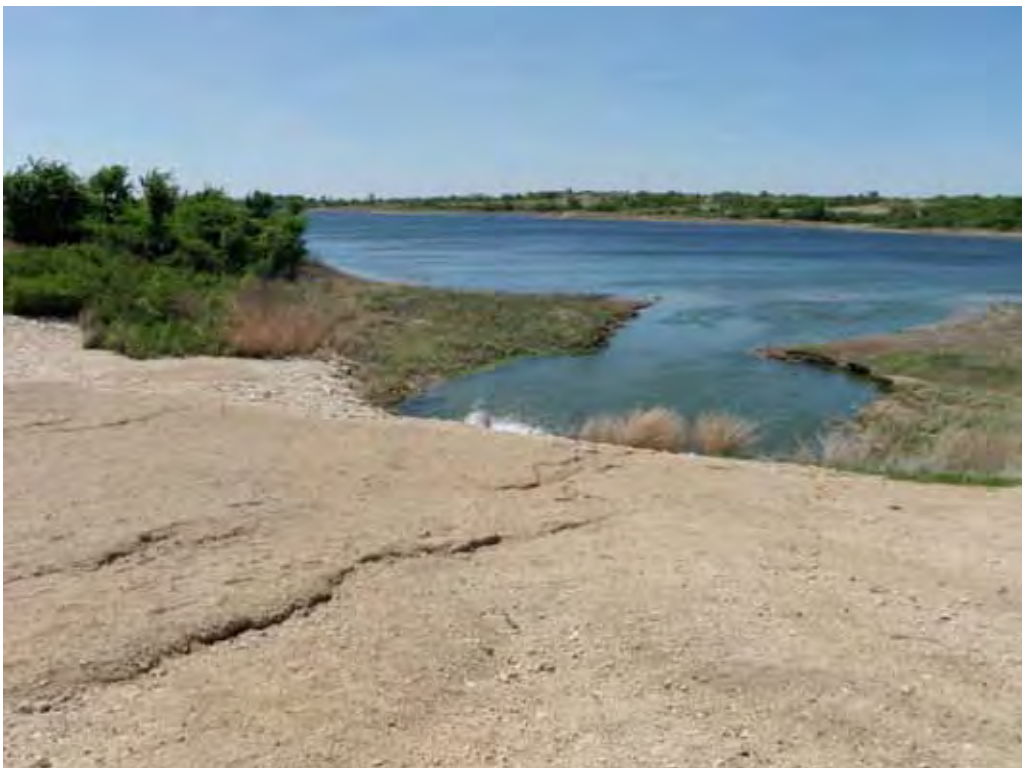
**Photo BAP 6 - Outlet Works Outlet – Looking downstream from dam crest at outlet pipe. (Note: Minor erosion gullies on downstream slope)**

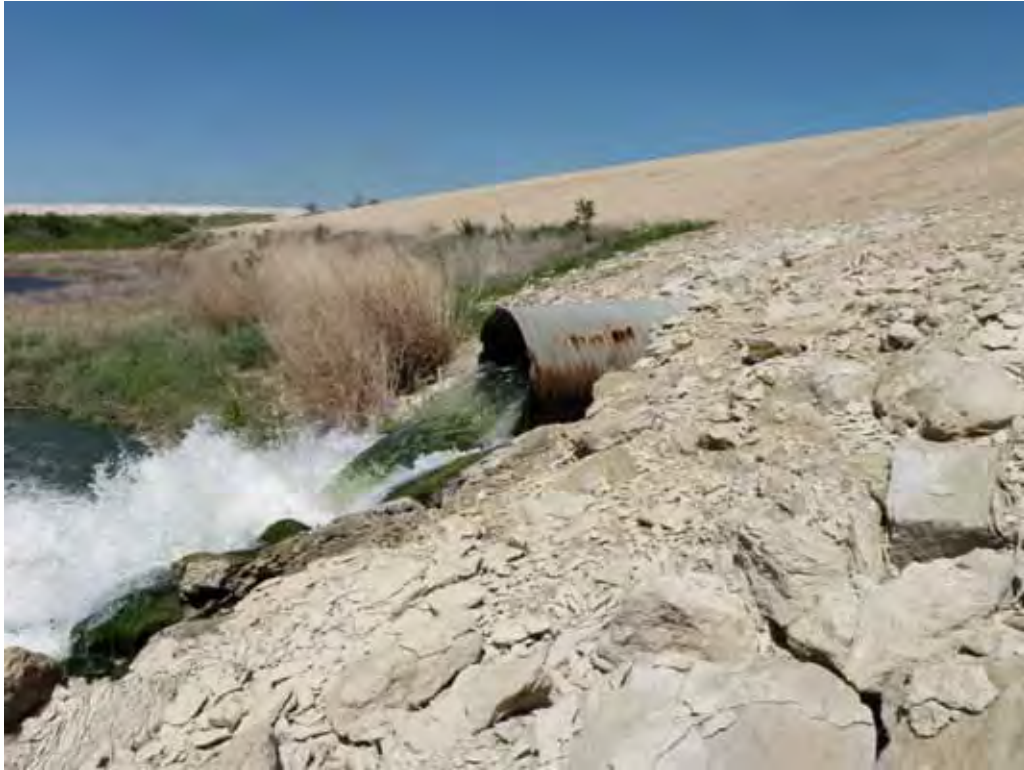
**Photo BAP 7 - Outlet Works Outlet – Looking at profile of outlet pipe, standing near toe of emergency spillway. (Note: Corrosion through pipe side walls)**

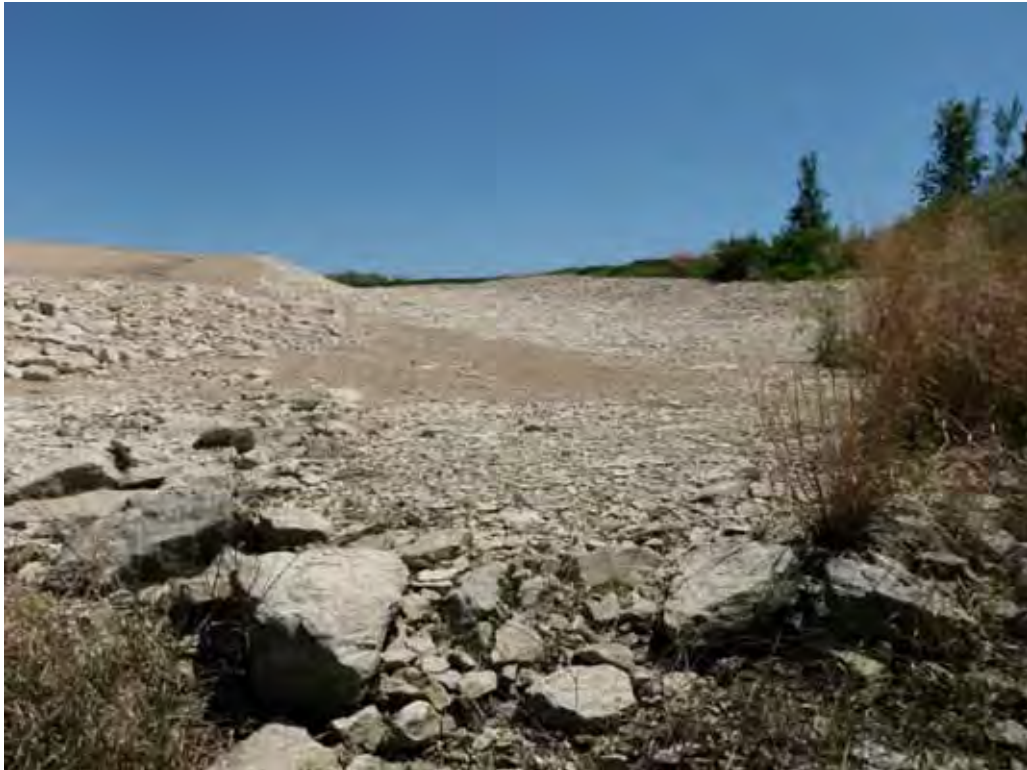
**Photo BAP 9 - Emergency Spillway – Looking upstream near the end of the riprap lined channel.**

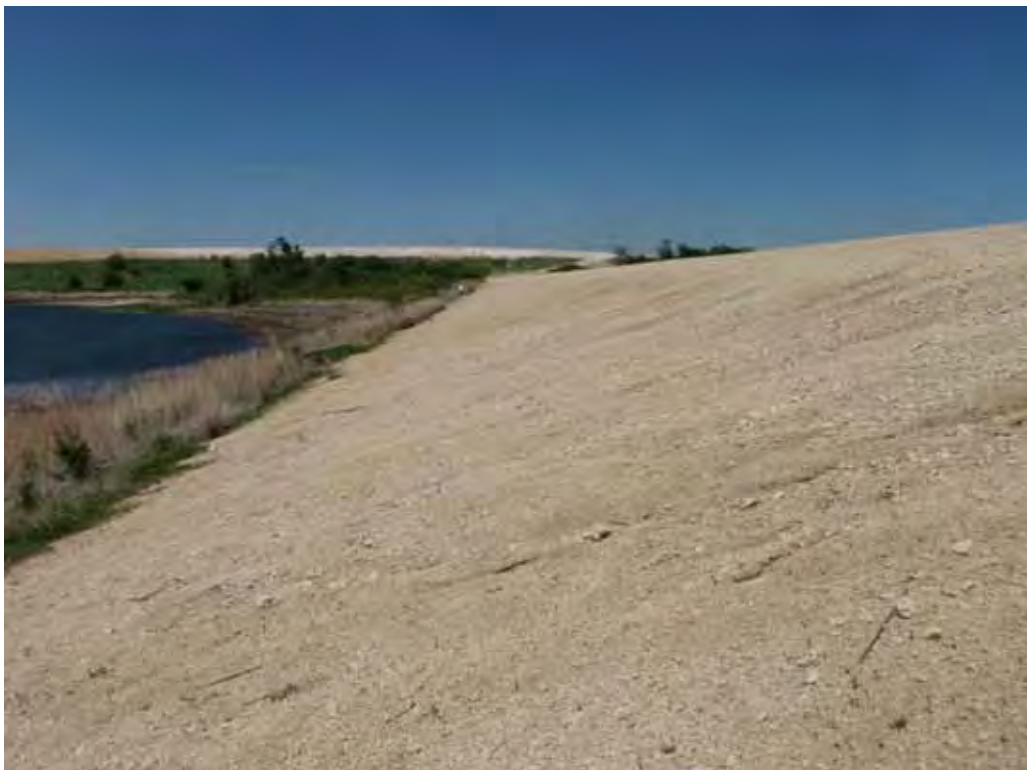
The downstream slope of the dam appeared to be in good condition. No obvious signs of slumping or instability were observed on the downstream slope (Photo BAP 10, BAP 12, and BAP 16). The downstream slope has no erosion protection. Several locations along the

**Photo BAP 10 - Downstream Slope – Looking towards right abutment standing on downstream slope near left abutment.**

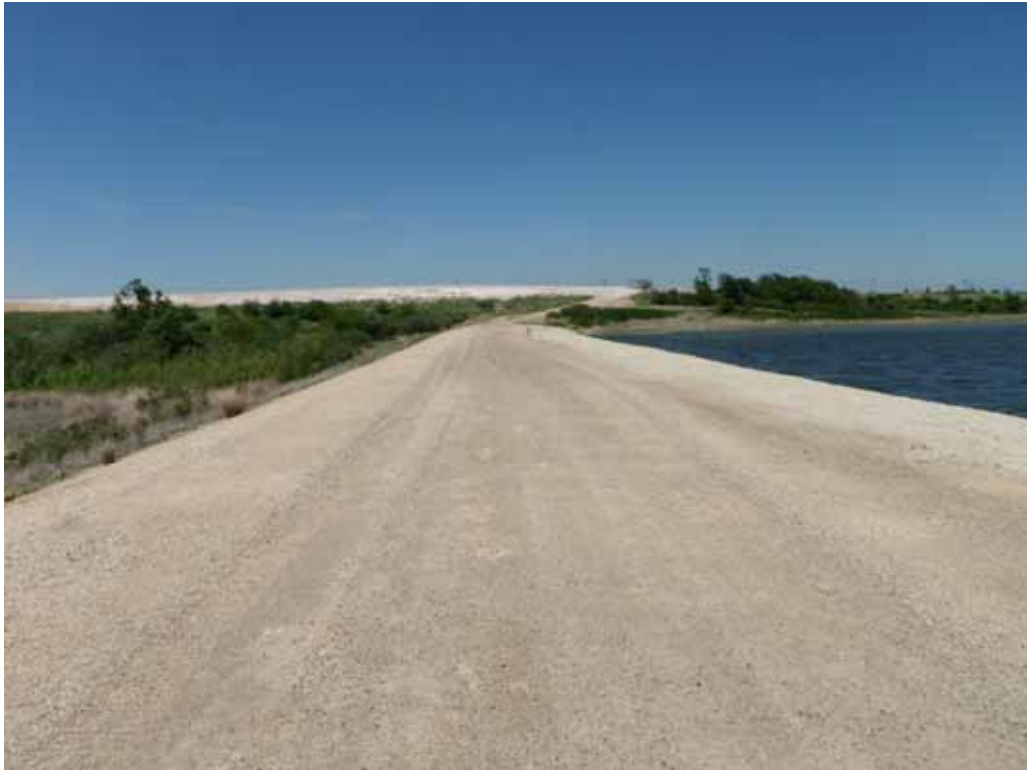
The dam crest appeared to be in good condition. No signs of cracking or settlement were observed during the assessment. No vegetation was observed on the dam crest (Photos BAP 11, BAP 13).

**Photo BAP 11 - Dam Crest – Looking towards right abutment standing at dam centerline.**

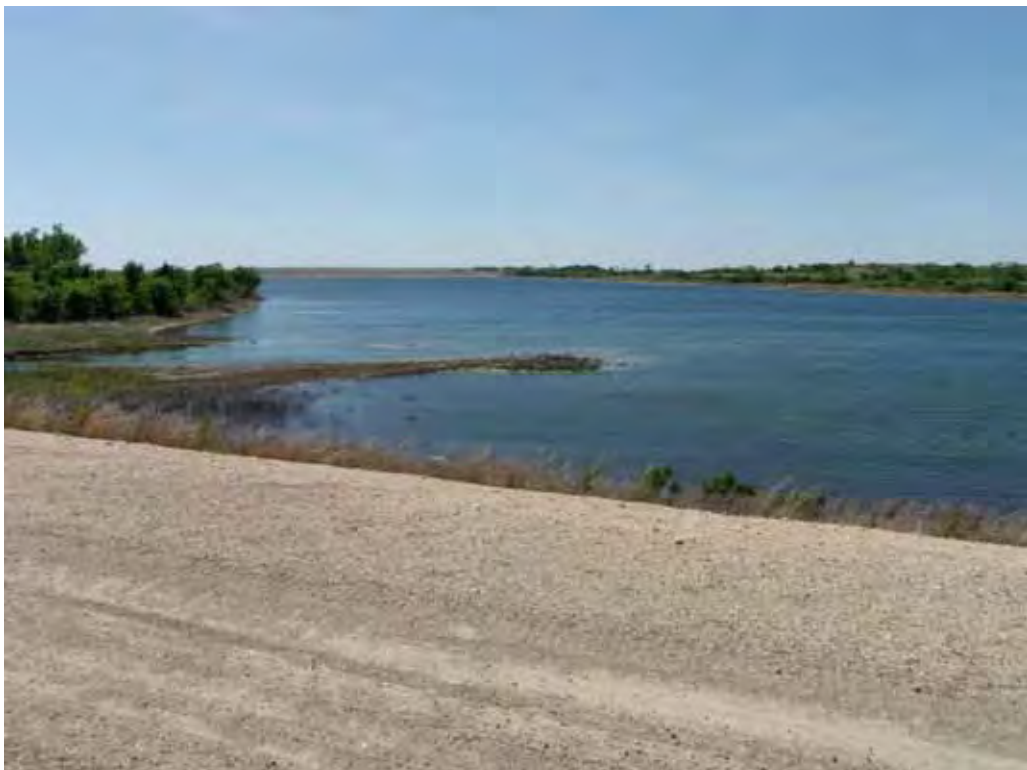
**Photo BAP 12 - Downstream Slope - Looking downstream towards Bottom Ash Lake Dam, near centerline of dam crest.**

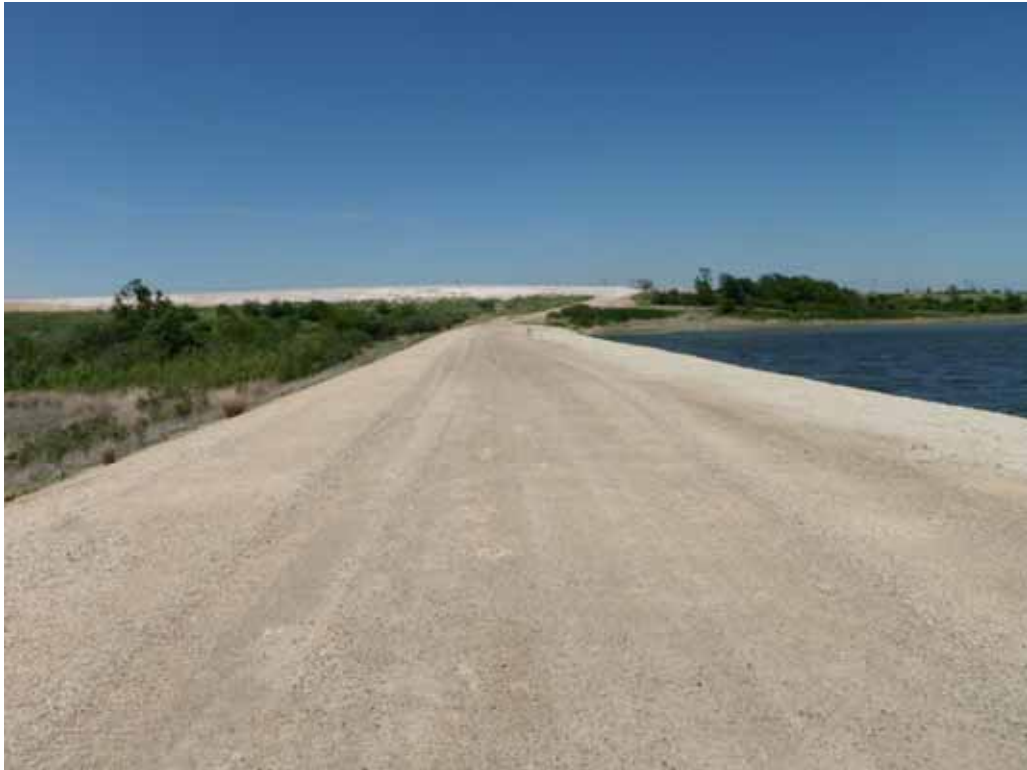
**Photo BAP 13 - Dam Crest – Looking towards left abutment standing at dam centerline.**

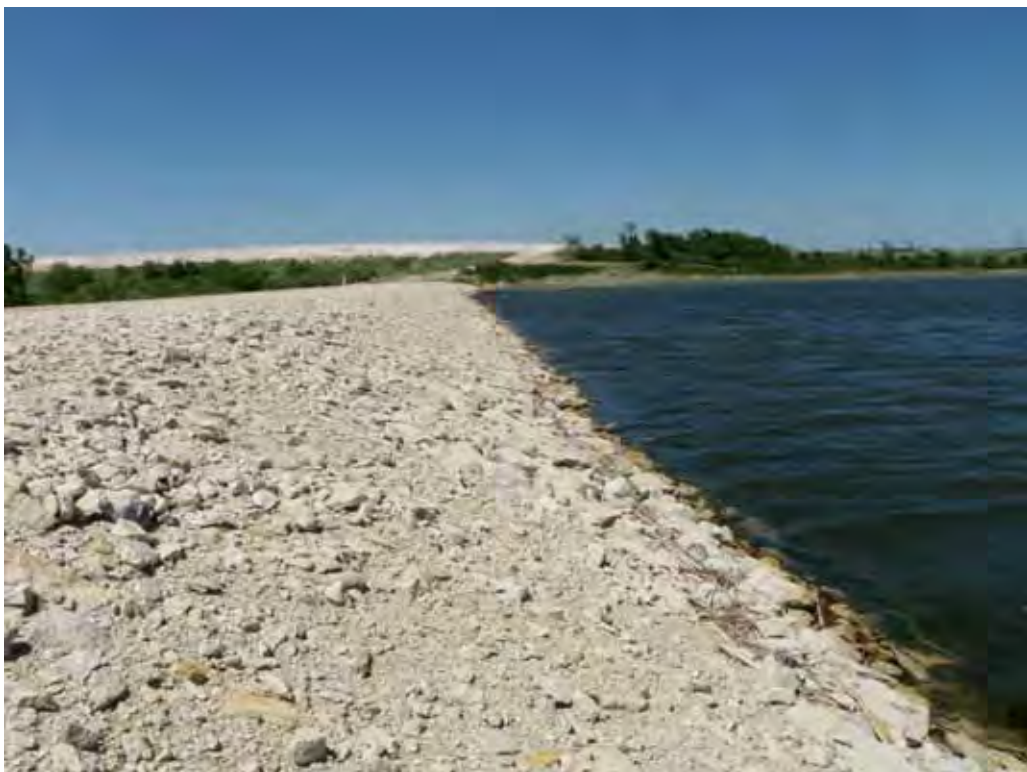
The upstream slope of the dam is protected by riprap and appeared to be in excellent condition. No vegetation or signs of instability were observed along the upstream slope (Photos BAP 14, BAP 15).

**Photo BAP 14 - Upstream Slope – Looking at upstream slope towards right abutment, standing about halfway up slope, near dam centerline.**

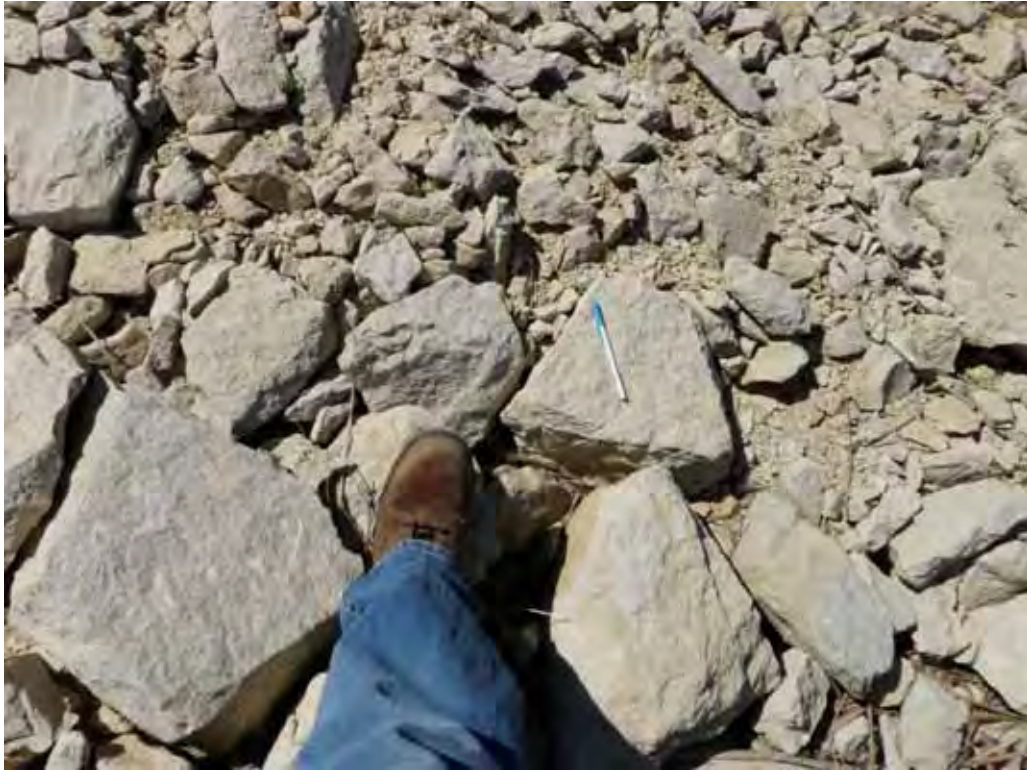
**Photo BAP 15 - Upstream Slope – Detail and scale, typical of upstream riprap slope protection.**

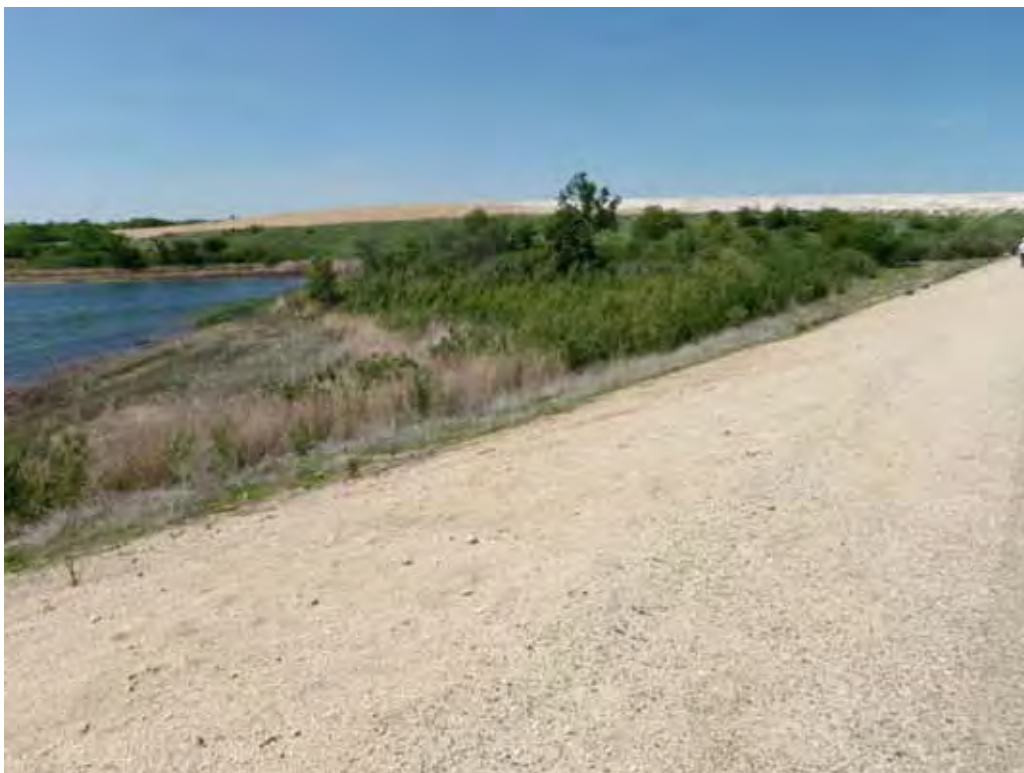
**Photo BAP 16 - Downstream Slope – Looking at downstream slope and significant vegetation at toe of slope.**

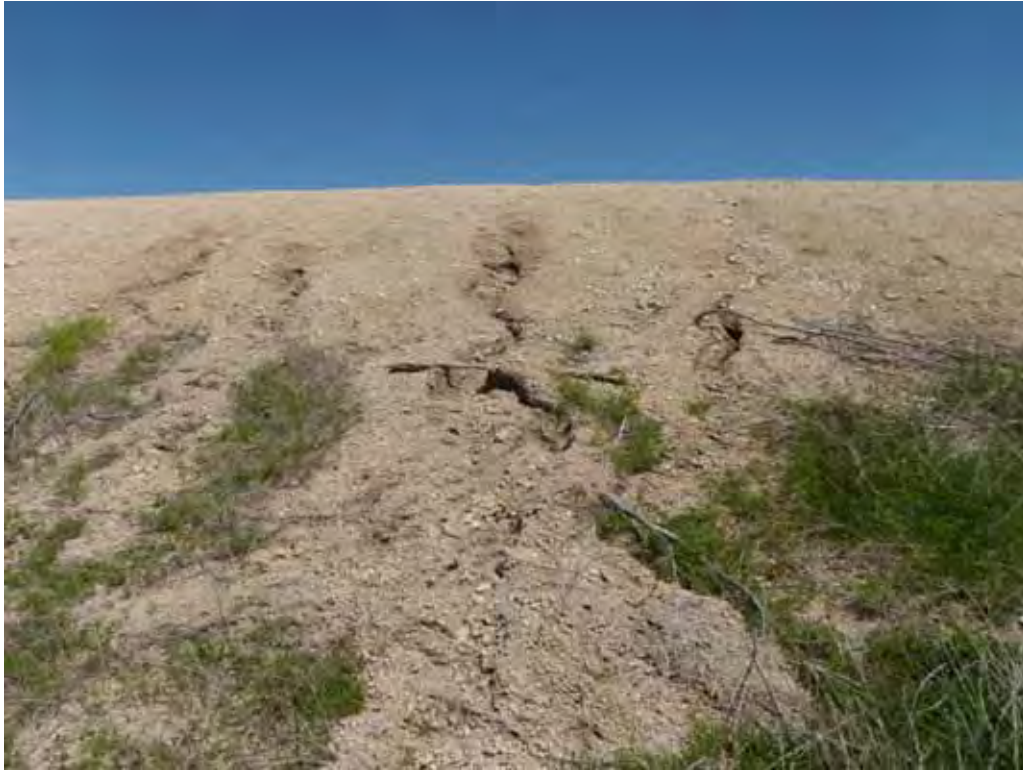
**Photo BAP 17 - Downstream Slope – Close up of minor surface erosion and gullies forming on downstream slope of dam.**
